Pawtuxet River Restoration
Warwick/Cranston, RI
Partial Removal at Spring Low Tide

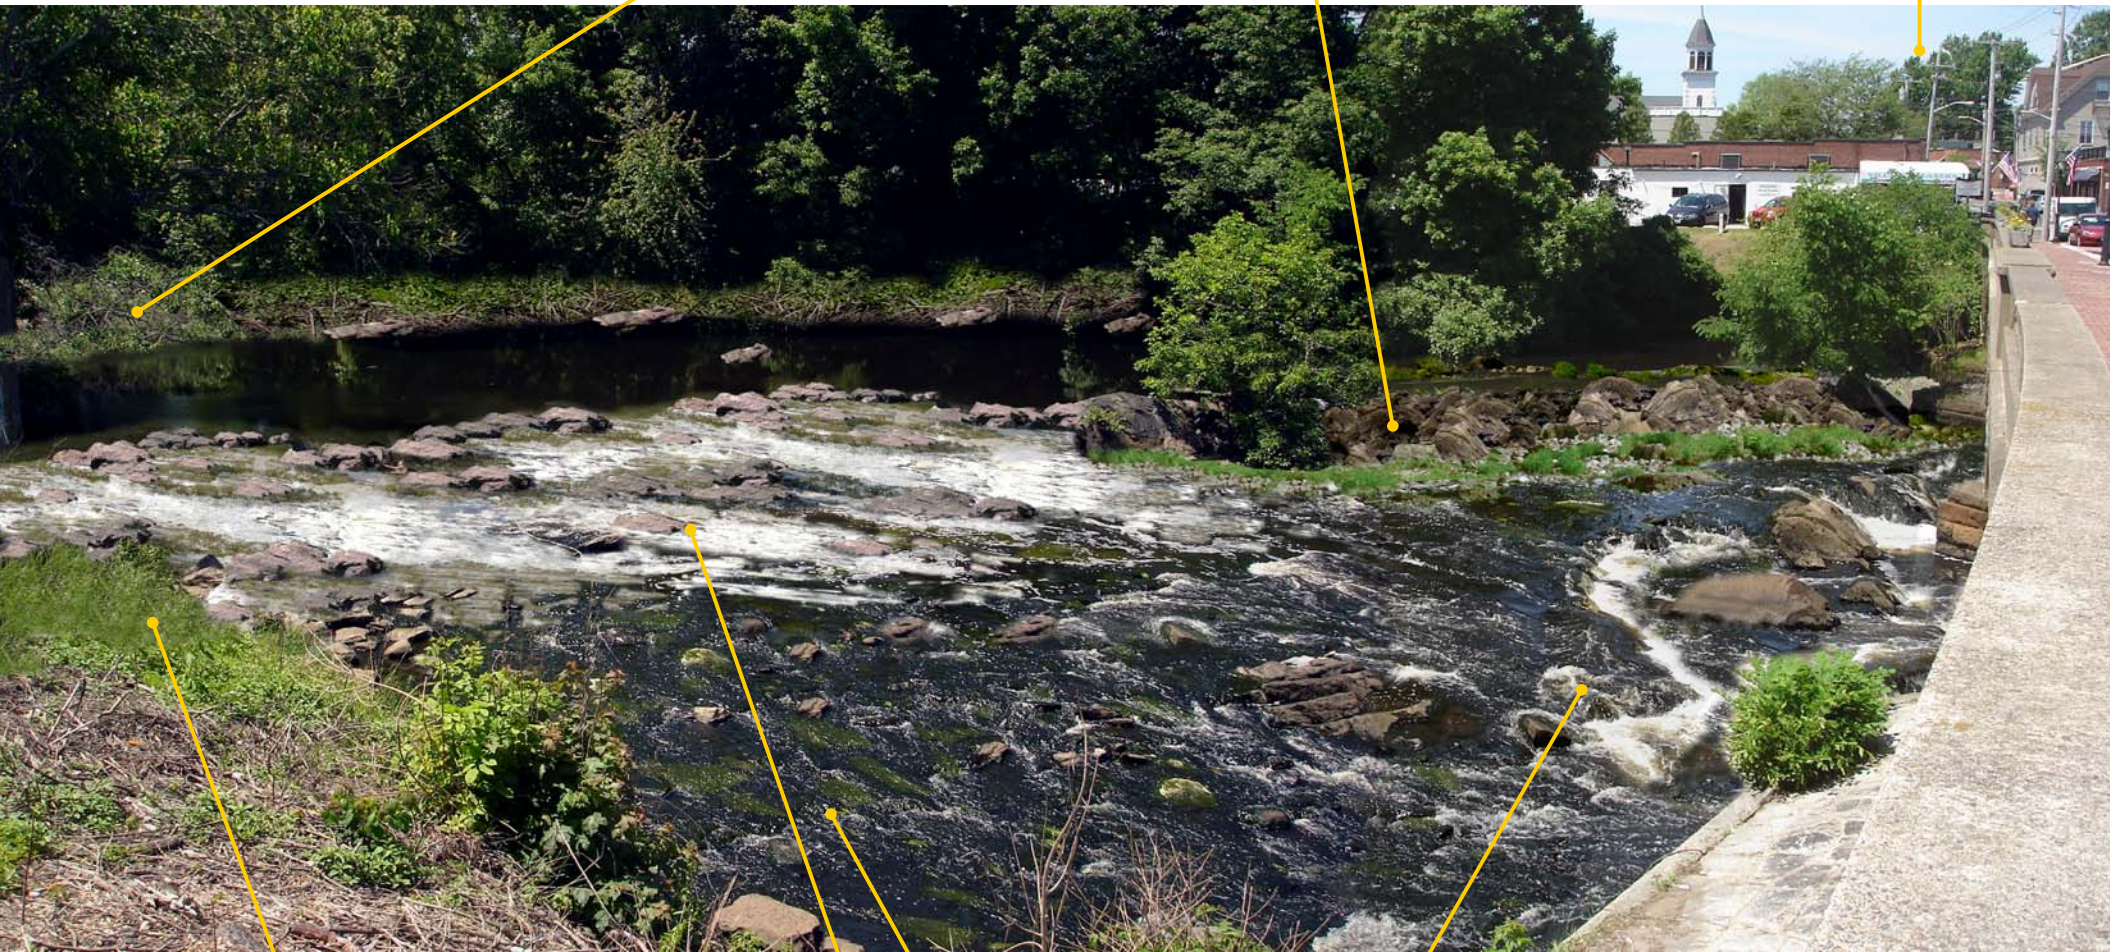
1 to 2 Feet Bank Exposure and Smaller Impoundment

No River Flow over Dam. Placed Boulder Slope to Hide the Existing Dam to Remain. The Stone Shall Match Color, Texture, and be of Appropriate Size to Appear as Boulders, not Riprap

Increased Bank Exposure; However, not as Significant as August Flow

Exposed Rock Outcrop Flow Hiding Majority of Outcrop under Normal/Average Flow

Low Tide Reveals More Outcrops & Rapids Compared to High Tide

Increased Whitewater

June 15, 2007 Q = 228± cfs (Average Flow)
