#### Restoration of Tern Nesting Habitat at Bird Island, Massachusetts

Carolyn Mostello 6 October 2023

### Bird Island, Buzzards Bay, MA

#### Restoration

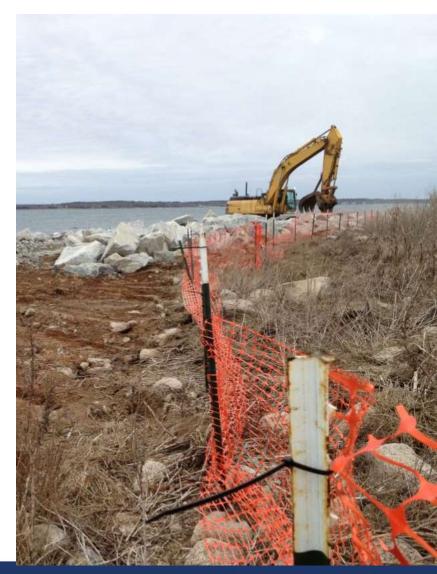
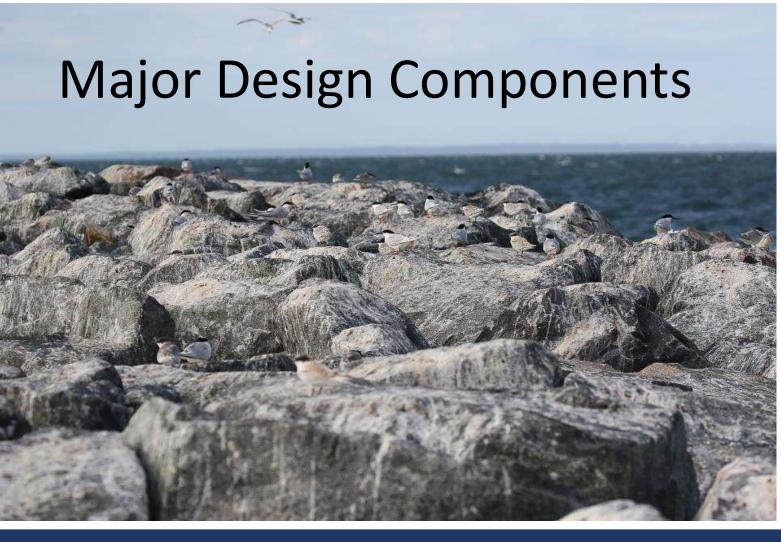
- wider
- higher (+2.5')
- sloping face
- voids

# Nourished with gravelly sand

- 个nesting habitat
- ↓salt marsh

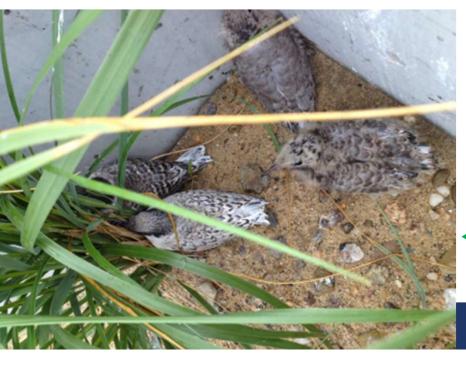
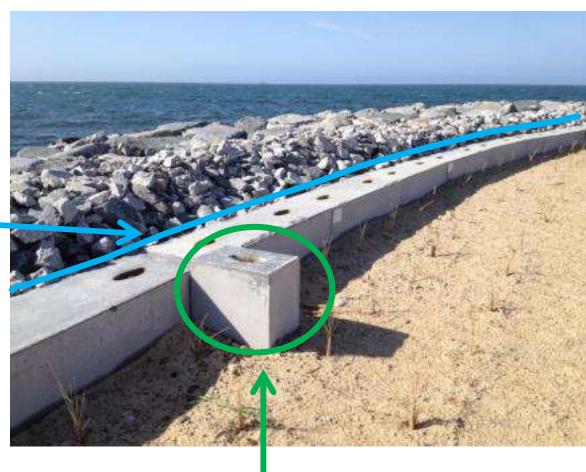
Chick curb to prevent access to revetment

Chick bumpers to prevent "edge running"

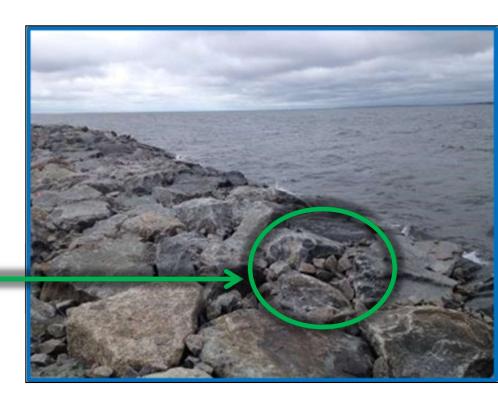
### Common Tern entrapments

adults &
   fledglings
   explored crevices
- 3 stones deep, tightly spaced
  - Problem for COTE
- Voids chinked with 15-20 cm stone
- Surplus provided for future

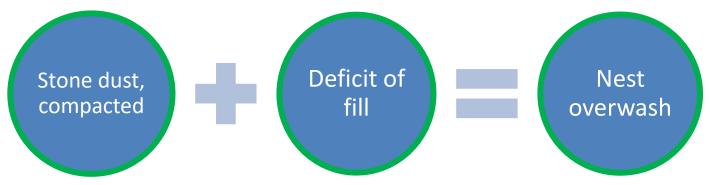
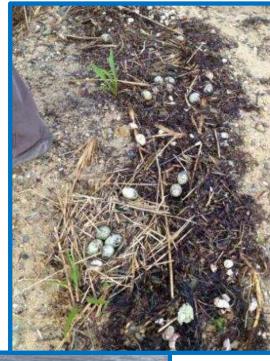
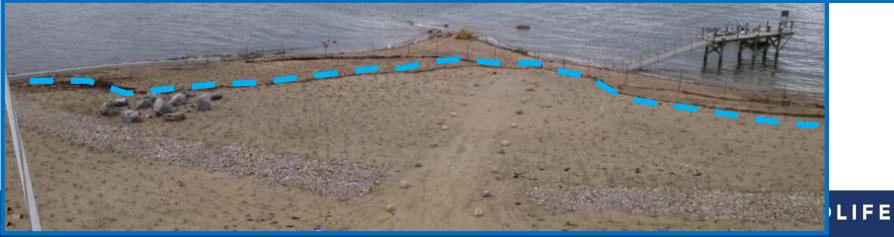
#### Habitat degradation & overwash

Staging area for materials – formerly major COTE area

Added material

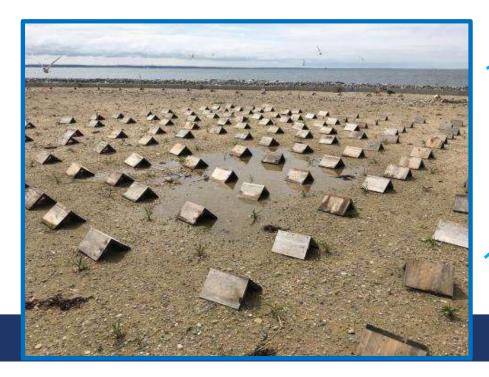
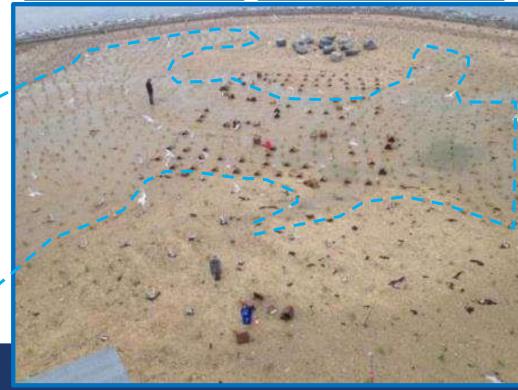
### Poor drainage

- QC issue with nourishment (too fine)
- Pooling rainwater
- Sub-surface saturation

Installed cobble drainage ditches, connected to cobble ring, which was connected to revetment at low points of island (\*)

Capped with highly permeable fill
