# How does the bay respond to changes in the watershed?

## A benthic habitat perspective

**Emily Shumchenia**

NBEP Science Advisory Committee

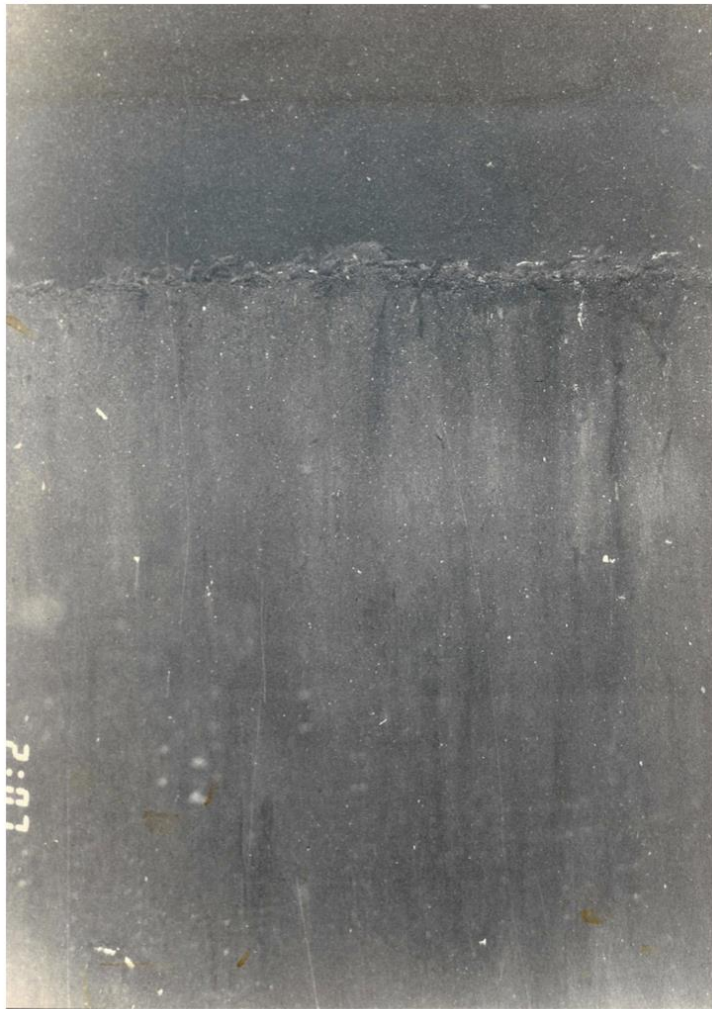
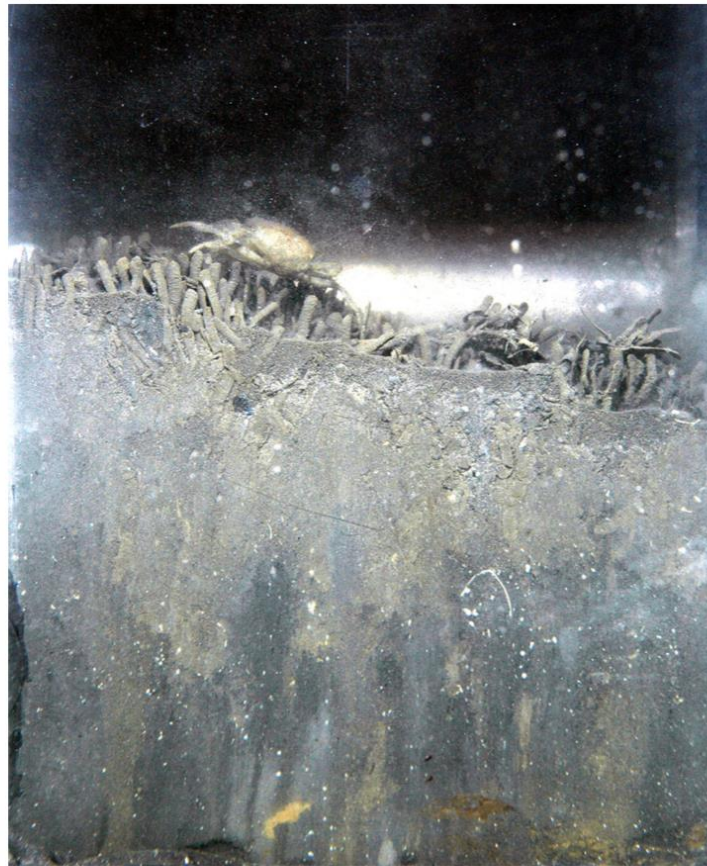
**PR-3**

***Ampelisca* biotopes appear to track critical boundaries in organic enrichment between high and low quality habitats**

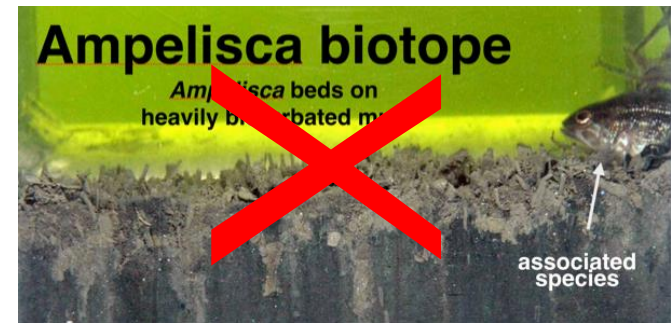
# What happened to *Ampelisca*?

8 – Small tube-building fauna (new biotope)

8 – Burrowing fauna on mud (dominant biotope in 1988)

4 – Organic mud with tolerant fauna (Greenwich Bay & Allen Harbor)

1 – Burrowing and tube-building fauna on sandy mud (Allen Harbor)
